H M Home Inspection Services

Your Property Inspection Report

3514 Royal Troon Avenue, Fort Collins, Colorado 80524

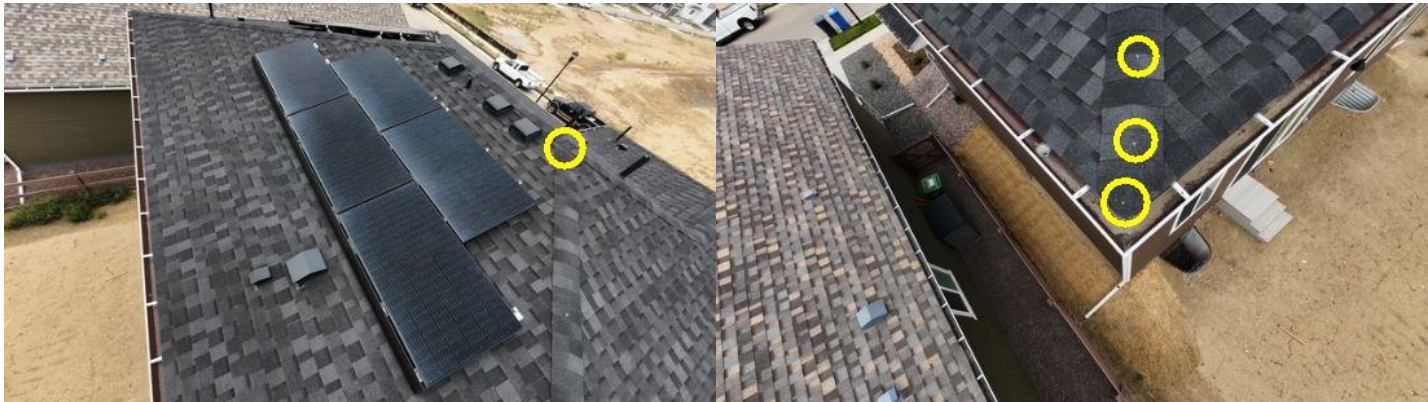
Exterior Areas		
Page 11 Item: 1	Roof

Possible nail heads are visible on the roof surface. Exposed fasteners should be properly sealed to help prevent moisture intrusion and deterioration.		Possible nail heads are visible on the roof surface. Exposed fasteners should be properly sealed to help prevent moisture intrusion and deterioration.
Page 16 Item: 4	Siding	<ul style="list-style-type: none"> • Caulk and seal all gaps, cracks and openings. • Some siding nails are protruding through the siding. This condition can allow moisture intrusion, damage to the siding material, and reduce the overall effectiveness of the exterior cladding. Recommend repair or adjustment by qualified contractor to help maintain siding, integrity and weather resistance.

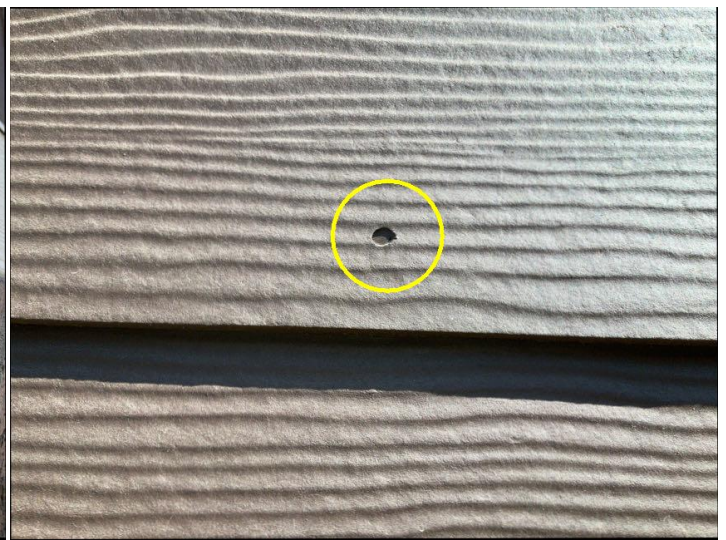
Some siding nails are protruding through the siding. This condition can allow moisture intrusion, damage to the siding material, and reduce the overall effectiveness of the exterior cladding. Recommend repair or adjustment by qualified contractor to help maintain siding, integrity and weather resistance.

Caulk and seal all gaps, cracks and openings. Left side of house just past front porch.

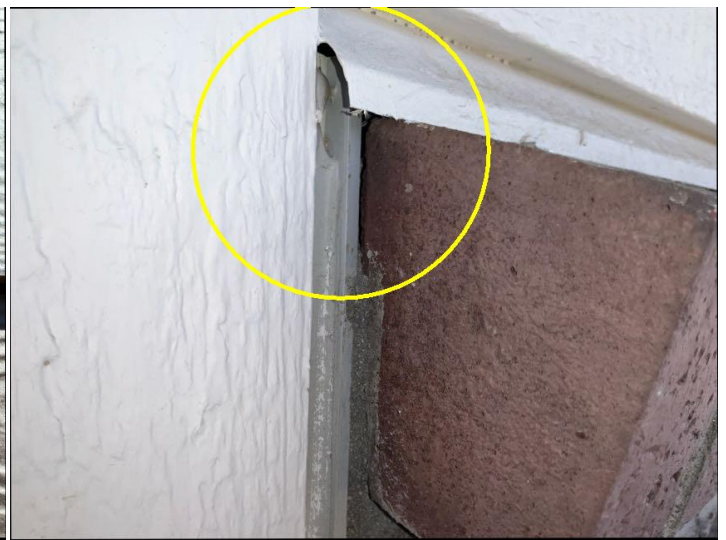
Caulk and seal all gaps, cracks and openings.

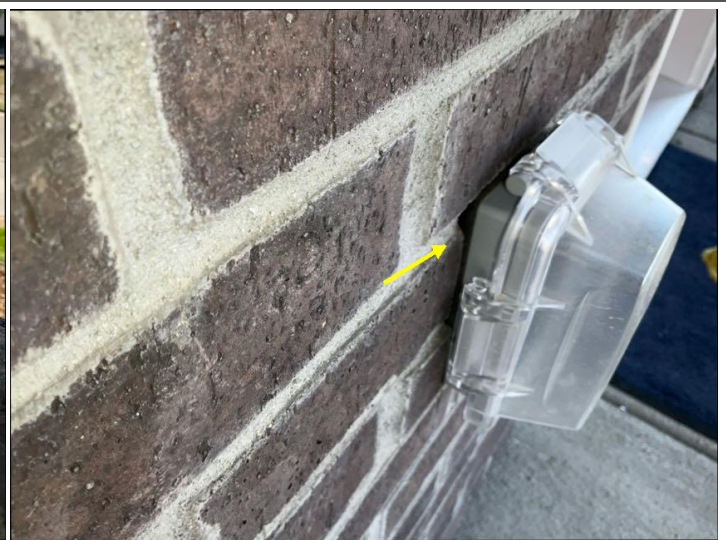
Front porch outlet - Caulk and seal all gaps, cracks and openings.

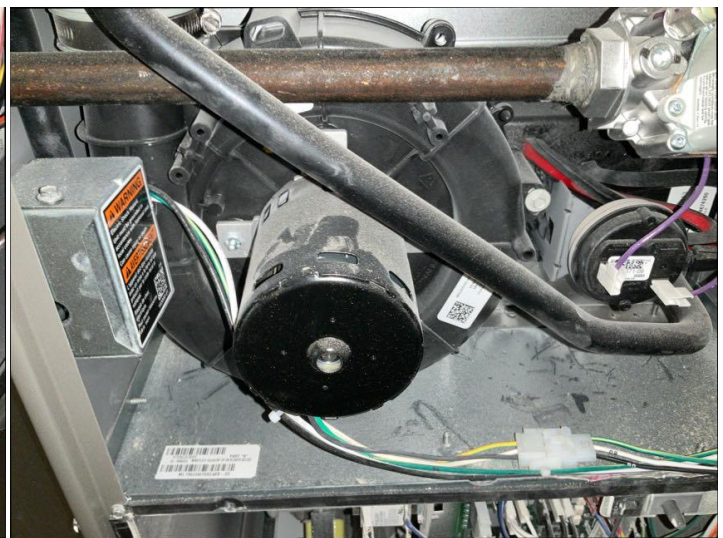
The interior of the furnace was found to be covered with drywall dust at the time of inspection. Drywall dust can negatively affect system performance, air quality, and components over time. Recommend monitoring and having the system evaluated/serviced by a licensed HVAC professional to ensure no lasting damage has occurred.

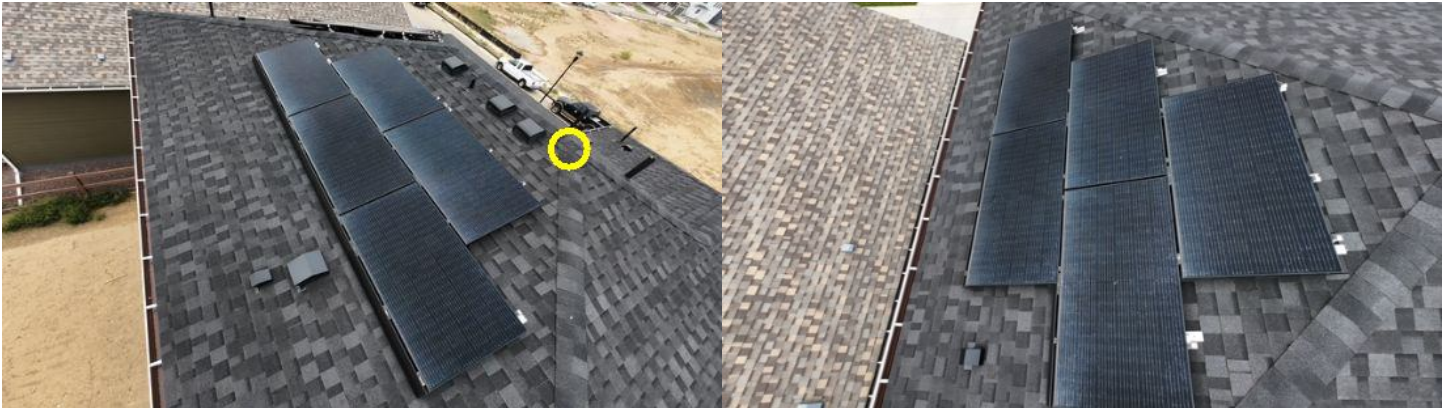
Possible nail heads are visible on the roof surface. Exposed fasteners should be properly sealed to help prevent moisture intrusion and deterioration.

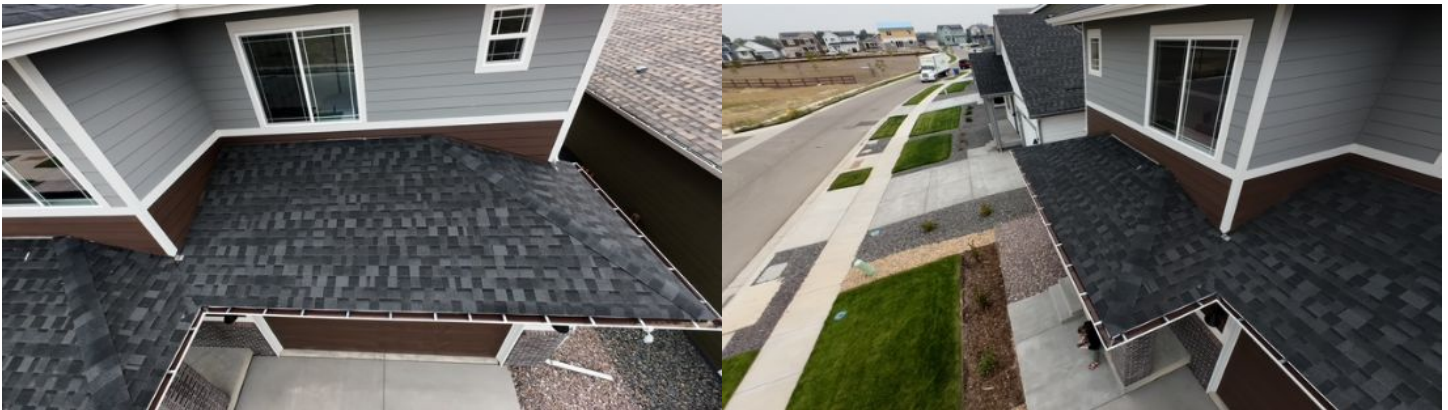
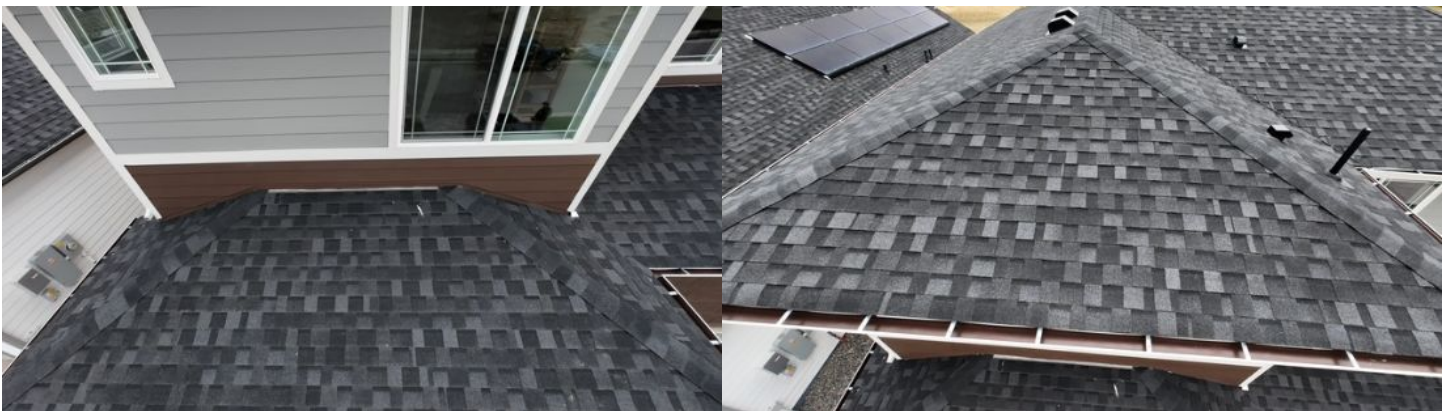
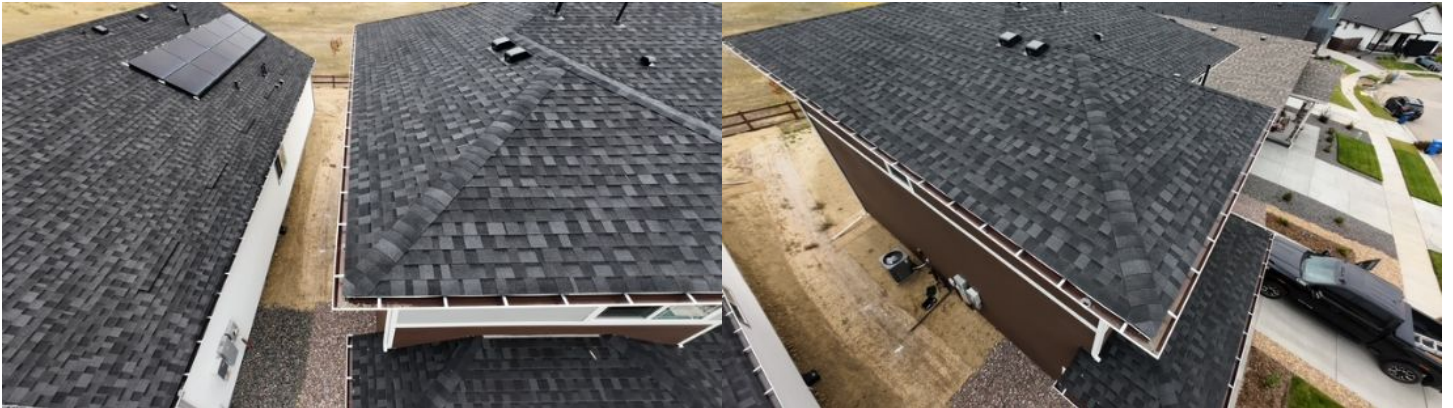
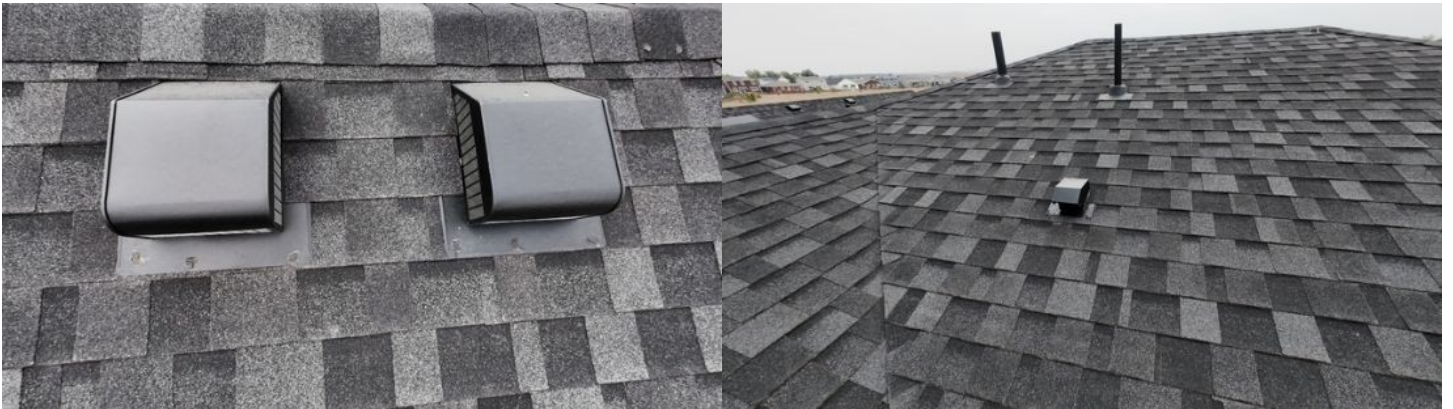
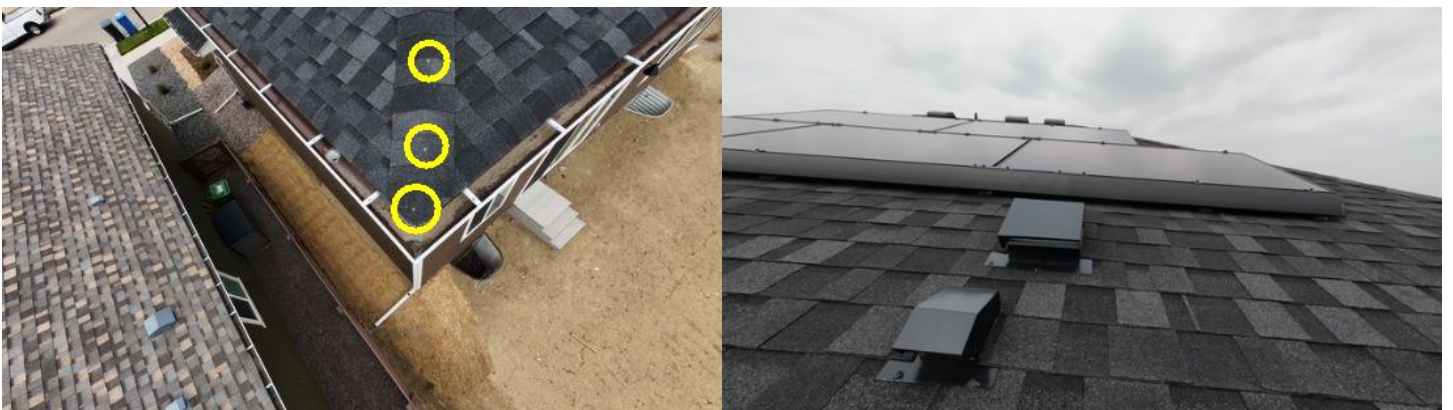
Possible nail heads are visible on the roof surface. Exposed fasteners should be properly sealed to help prevent moisture intrusion and deterioration.

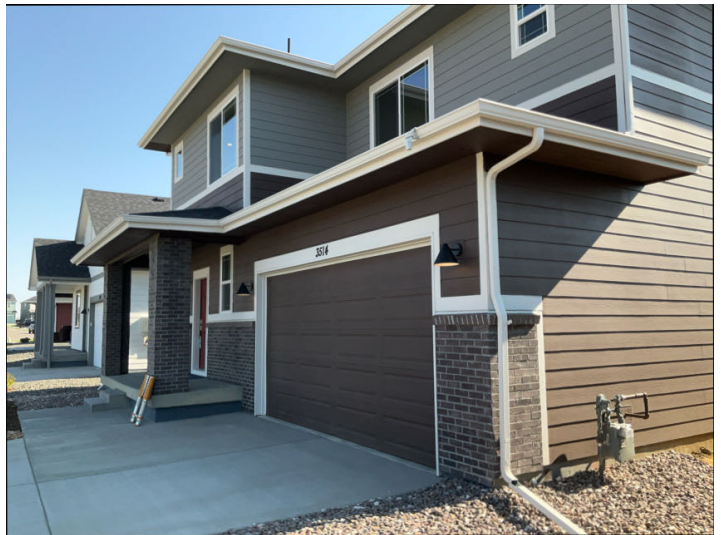
Caulk and seal all gaps, cracks and openings. Left side of house just past front porch.

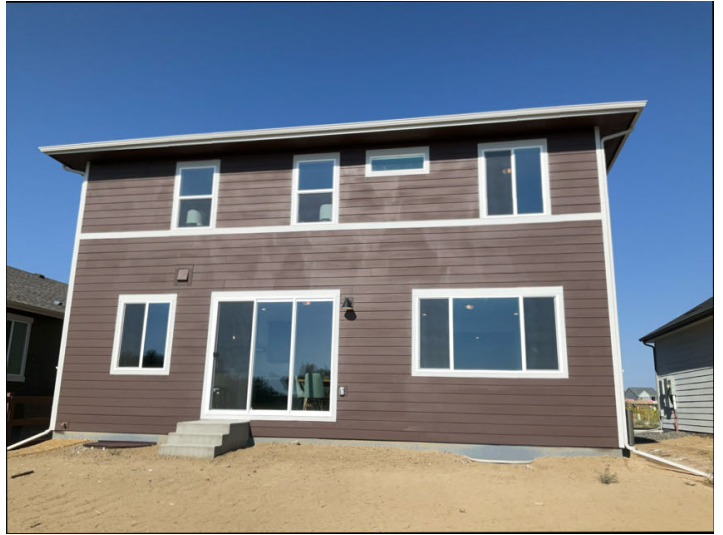
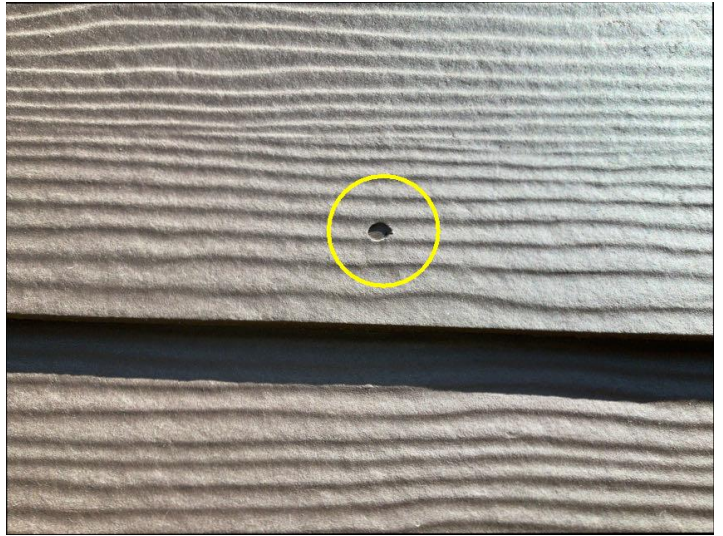
Some siding nails are protruding through the siding. This condition can allow moisture intrusion, damage to the siding material, and reduce the overall effectiveness of the exterior cladding. Recommend repair or adjustment by qualified contractor to help maintain siding, integrity and weather resistance.

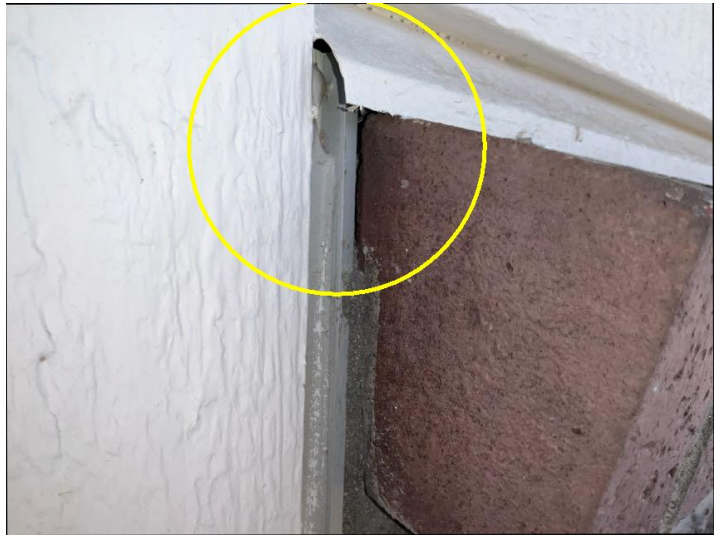
Caulk and seal all gaps, cracks and openings.

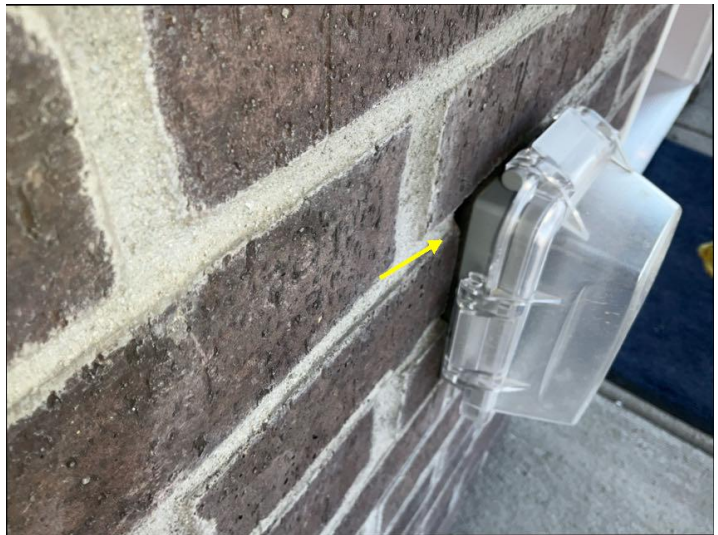
Front porch outlet - Caulk and seal all gaps, cracks and openings.

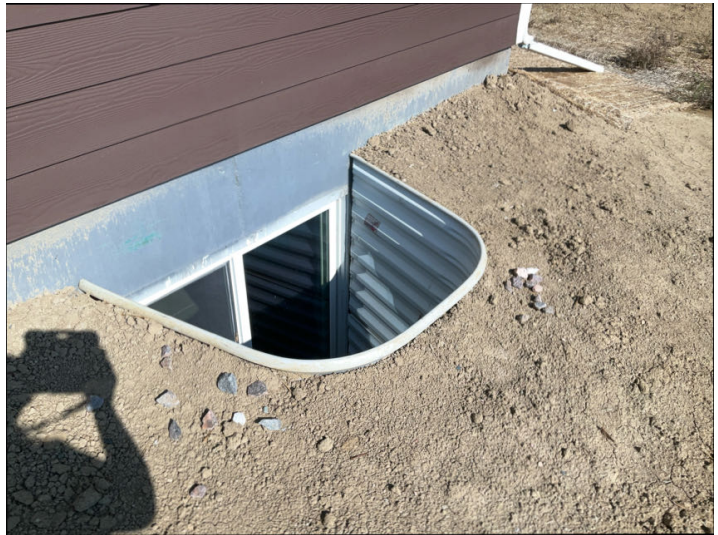
The property was missing a window well cover at the time of inspection. Missing covers can allow debris, water, and pests into the well, and in some cases create a safety hazard if someone were to step into it. Recommend installing properly fitting window well covers for protection and safety.

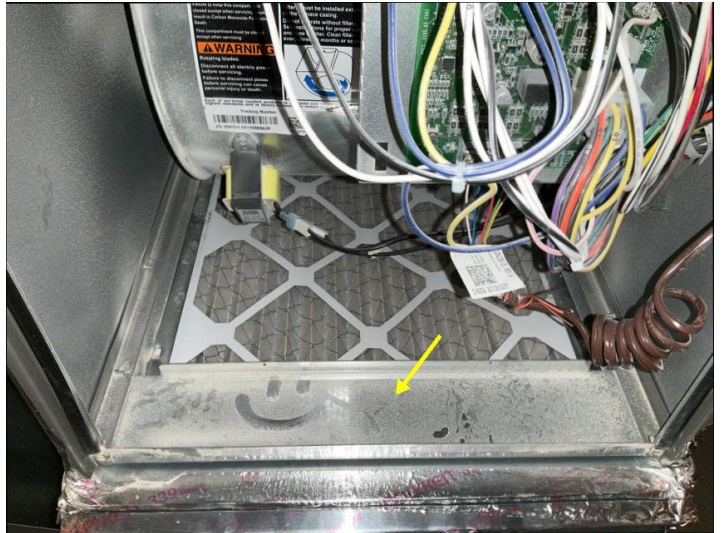
The interior of the furnace was found to be covered with drywall dust at the time of inspection. Drywall dust can negatively affect system performance, air quality, and components over time. Recommend monitoring and having the system evaluated/serviced by a licensed HVAC professional to ensure no lasting damage has occurred.

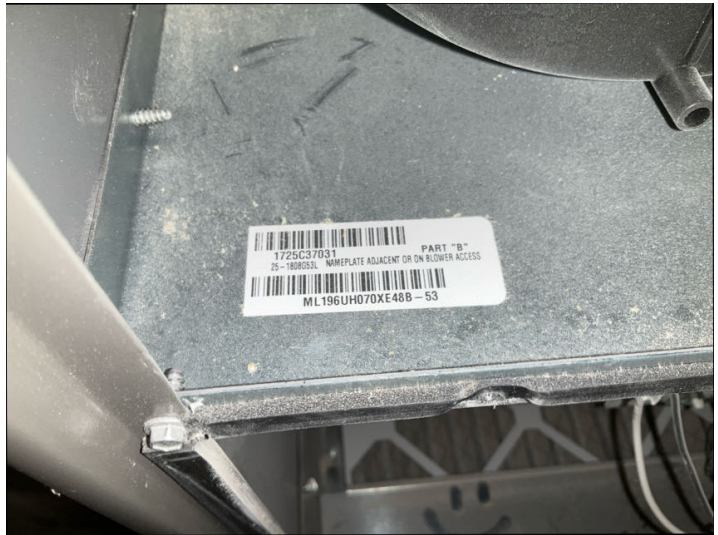
The interior of the furnace was found to be covered with drywall dust at the time of inspection. Drywall dust can negatively affect system performance, air quality, and components over time. Recommend monitoring and having the system evaluated/serviced by a licensed HVAC professional to ensure no lasting damage has occurred.

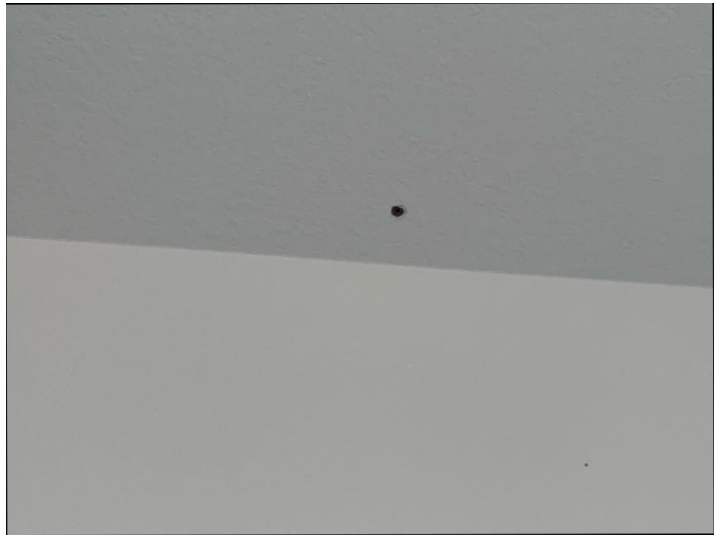
Damage at upstairs going into the loft area.
